Explanation of “cracking” seen on air springs in actuation

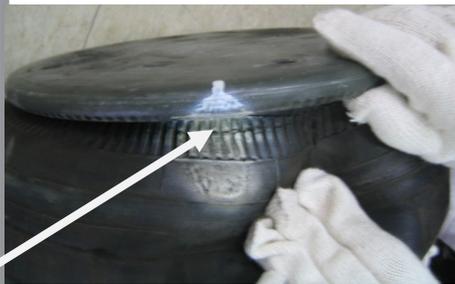
The process of folding the fabric over the wire creates an area called the “turn up”, and the end of the turn up area is where the ends of the fabric terminate. (See the illustration)

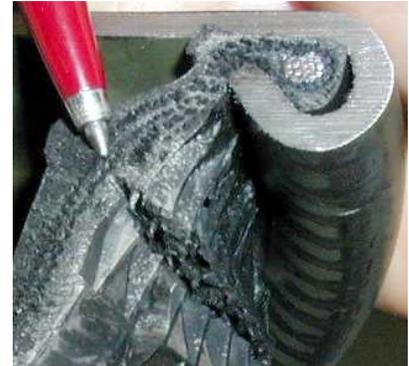
appear as a “crack” in the bellows, but it is actually the loose section of the turn-up separating from the bellows.

This is a common occurrence with all convoluted air springs and is not considered a failure or a manufacturing defect. We have seen parts last many years with this appearance. The performance of the part should not be affected. The rubber and fabric that is under tension are still held in place by the crimp of the bead plate.

If, however, you see the crack separating and there is visible fabric at the bottom of the crack you should look carefully at the application and perhaps replace the air spring. This condition is normally caused by overextension of the bellows and can lead to early failure.

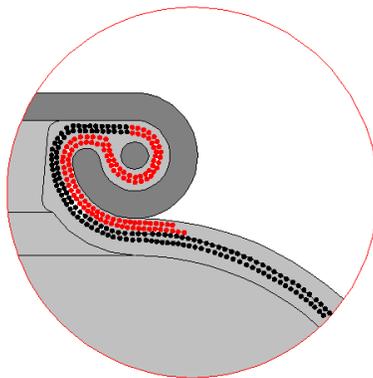
When using air springs as actuators, especially when using the full stroke of the spring, the rubber part will flex substantially. The fabric in the bellows is in tension during that flexing while the fabric in the turn-up just lays on the surface (*the black dots in the illustration below represent the cords that are under tension and the red dots represent cords that are not under tension*). This creates a shear force between the fabric in tension and the fabric on the surface. Because of this, it is common for the turn-up area to break loose from the bellows. This will
